Swedish Civil  
Contingencies  
Agency

# Demonstration of firefighting methodology for lithium-ion batteries

Application of methodology at various assembly levels  
(module, sub-pack, EV battery pack and vehicle)

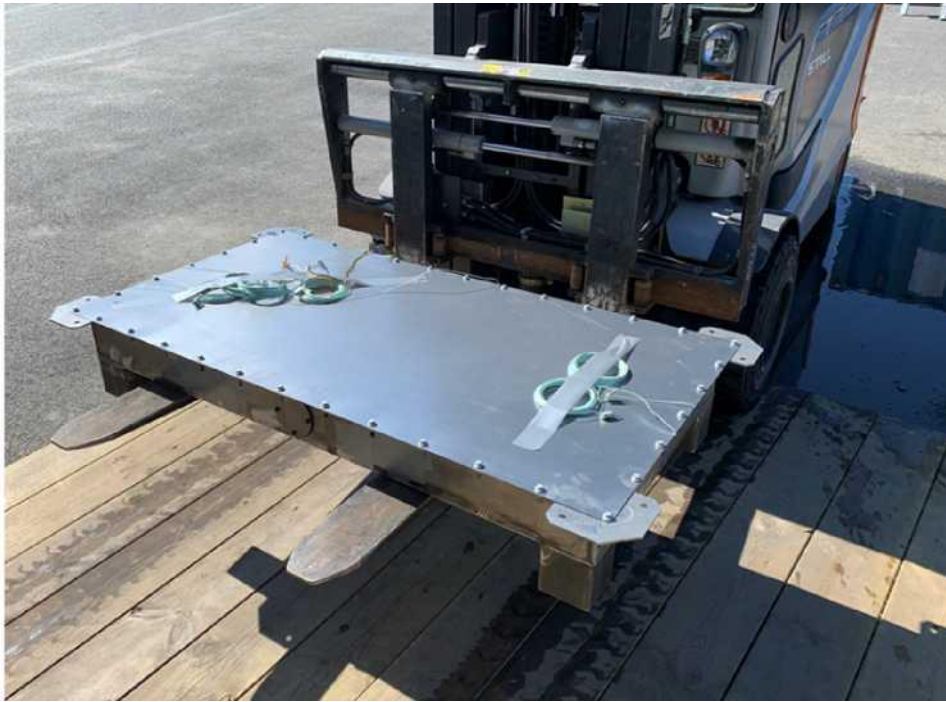
**Figure 2.** Sub-pack with attached lid, ready for transport to the test site.

Figure 2 shows the sub-pack with lid, ready for transport to the test site.

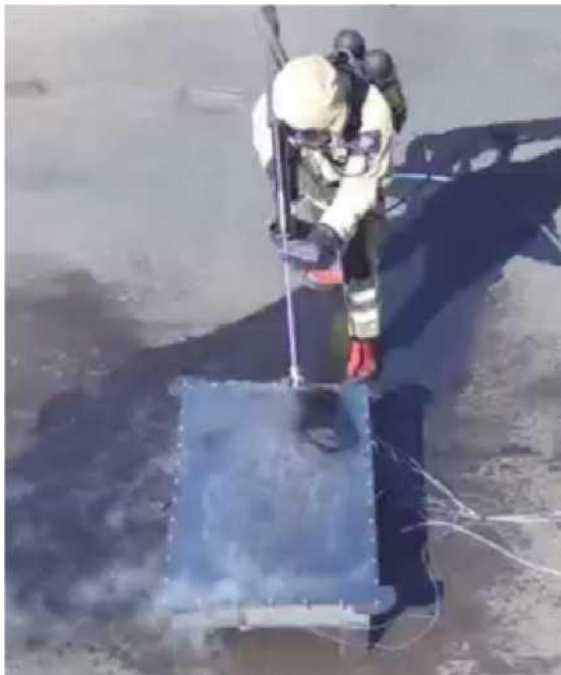
**Figure 6.** Firefighting with cutting extinguisher - test 1A.

After initiation of thermal runaway and ignition, thermal propagation in the battery commenced. Popping sounds could be heard when the cell valves were opened. Jets of flame and a relatively small amount of smoke seeped out because the sub-pack was glued and screwed shut, and the sheet-metal lid bent with the increasing pressure. A distinct discolouration appeared on the lid where the heat was most noticeable.

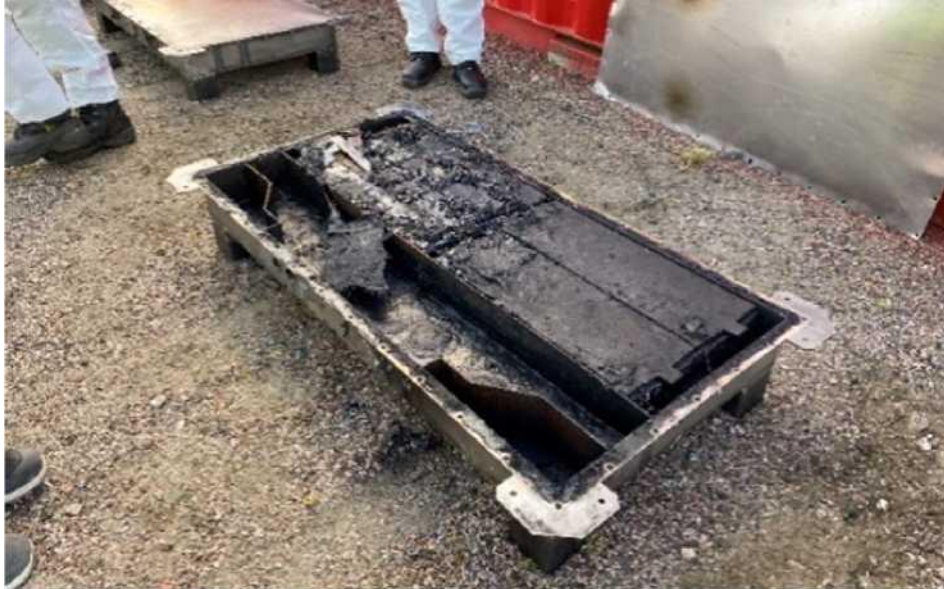
**Figure 7.** Sub-pack after extinguishing with a cutting extinguisher.

Voltage measurements of the battery modules showed that two of a total of four modules had full voltage (24 volts) and the other two modules measured 20 volts (see Figures 7 and 8).

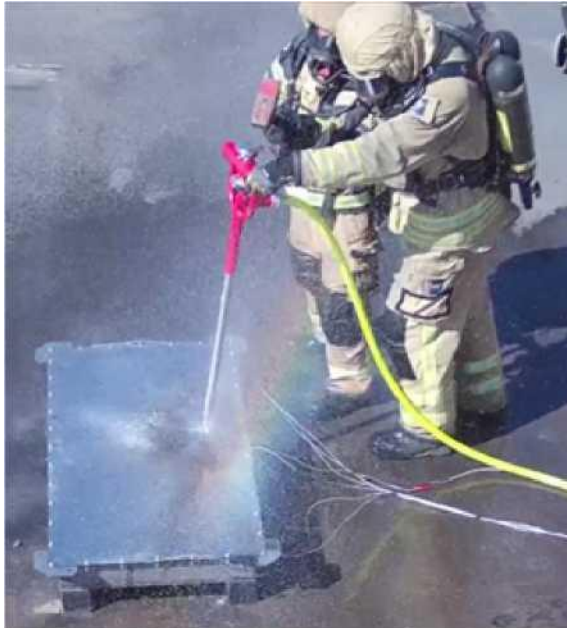
**Figure 9.** Firefighting with extinguishing lance - test 1B.

After the initiation of thermal runaway and ignition, heat generation continued, but at a slower rate than in the previous sub-test. To speed up fire development, gas burners were used at the bottom and side of the pack. Propagation could finally be detected with a popping sound. Jets of flame and a relatively small amount of smoke seeped out due to the tight closure of the sub-pack, and the sheet-metal lid bent with the increasing pressure. A distinct discolouration appeared on the lid where the heat was most noticeable.

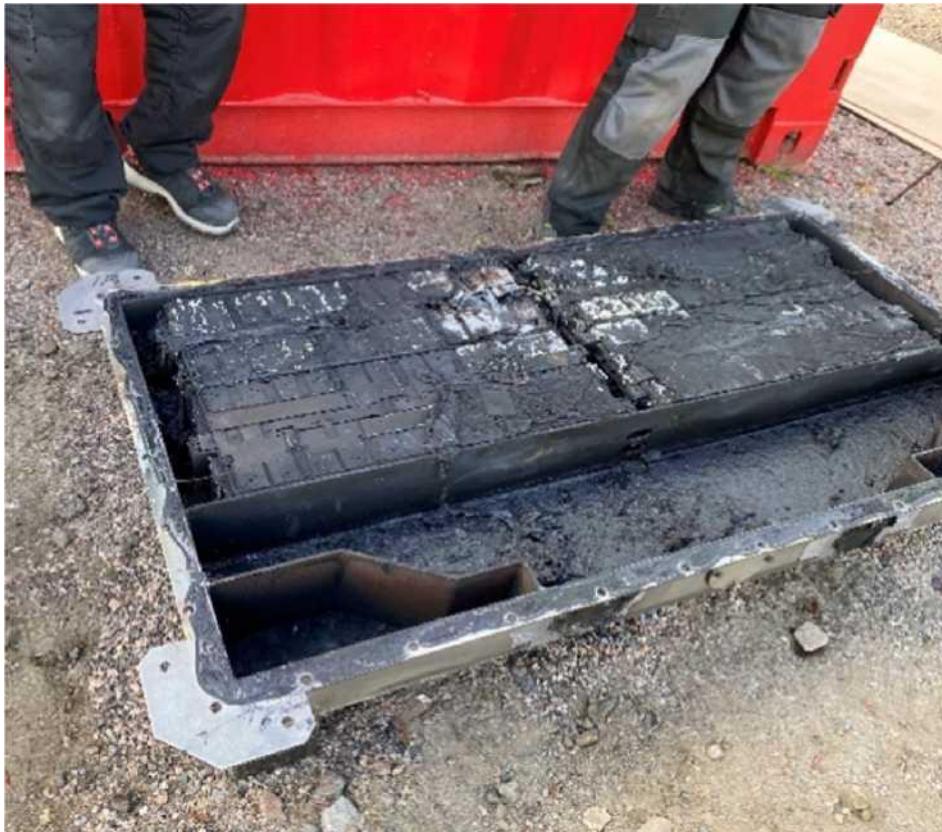
**Figure 10.** Sub-pack after extinguishing with e-extinguishing lance.

The voltage measurements of the battery modules showed that three of a total of four modules had full voltage (24 volts) and the pierced one measured 16.7 volts (see Figure 10 and Figure 11). This result indicates that propagation from the first to the second module did not occur. This further reinforces the assertion that it is difficult to determine the extent of thermal propagation in the battery during the fire.

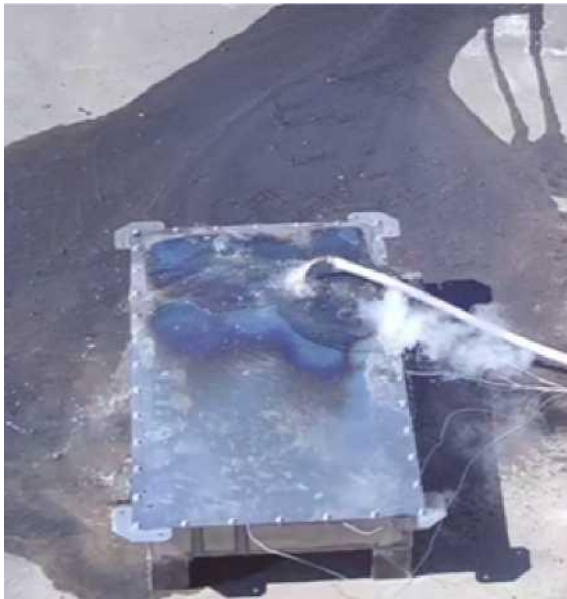
**Figure 12.** Firefighting with narrow hose and copper pipe - test 1C.

Following the initiation of thermal runaway and ignition, thermal propagation began in the battery, which could be heard and seen by smoke seeping out and the sheet-metal lid bending. A distinct discolouration appeared on the lid where the heat was most noticeable. The extinguishing was commenced when thermal propagation reached battery module 2 and the heat had clearly spread within the sub-pack. Holes were drilled, the copper pipe was inserted, and water flowed to cool the surrounding battery modules (see Figure 12). Extinguishing was ended when the temperature was stable below 50°C. Penetration of the battery pack produced strong jets of flame and small arcs. No re-ignition was observed.

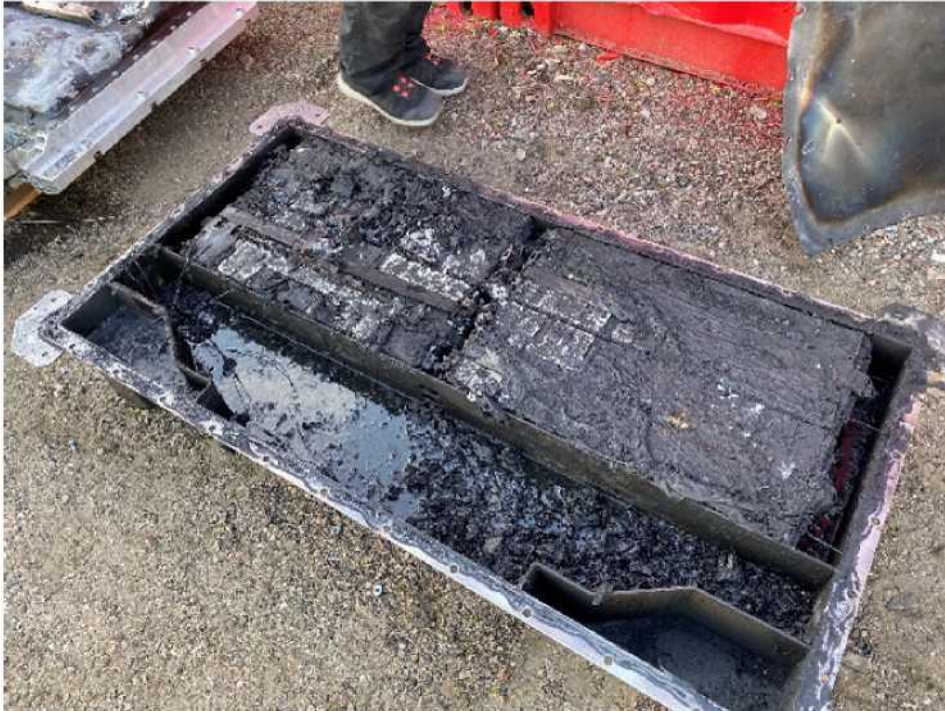
**Figure 13.** Sub-pack after extinguishing with narrow hose and copper pipe.

The voltage measurements of the battery modules showed that the module where thermal runaway was initiated had 5 volts, the neighbouring module had 16 volts and the two remaining modules had full voltage, i.e., 24 volts (see Figures 13 and 14).

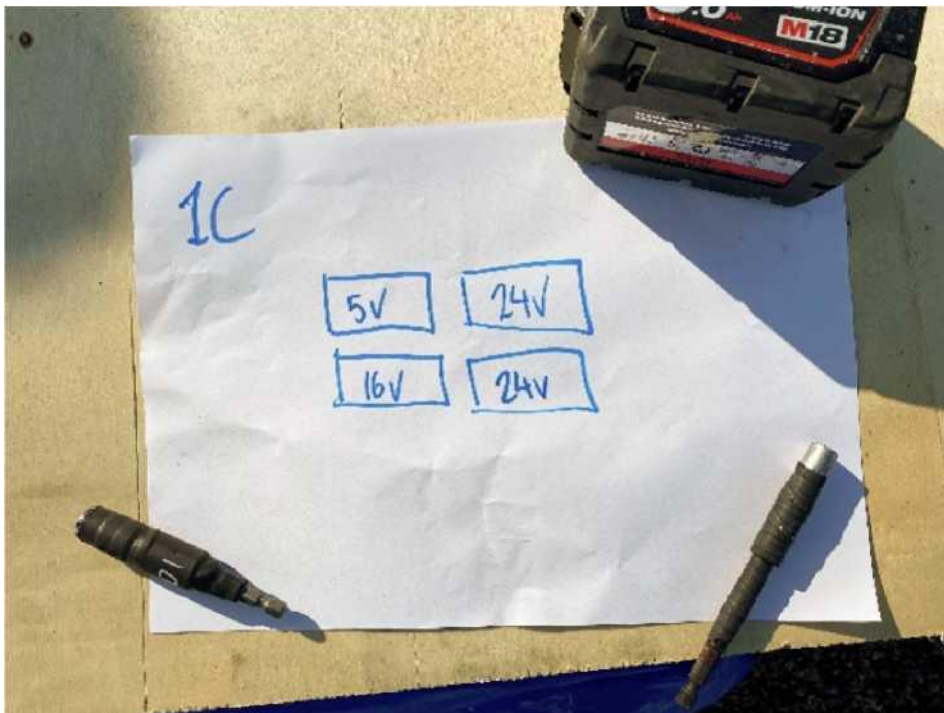
**Figure 14.** Remaining voltage after extinguishing..

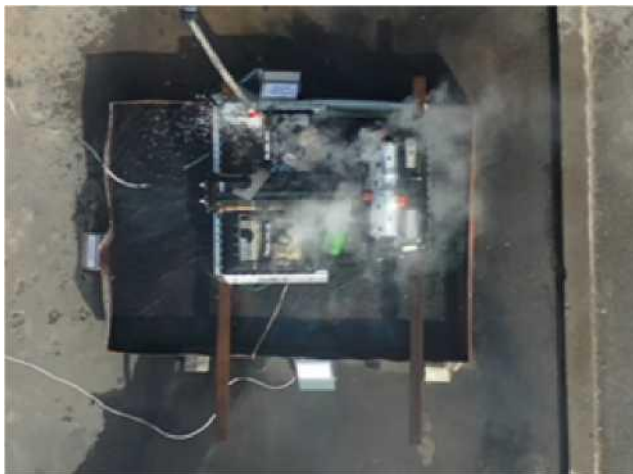
**Figure 15.** Extinguishing with narrow hose and spray pipe - test 2.

Extinguishing commenced. Piercing with an axe revealed jets of flame and small arcs, and battery module A was attacked with spray pipes that established a water flow and cooled the battery pack (see Figure 15). The piercing damaged unaffected battery cells, resulting in localised thermal runaway that was extinguished with application of water. Extinguishing was ended when the temperature was stable below 50 °C. No re-ignition was observed.

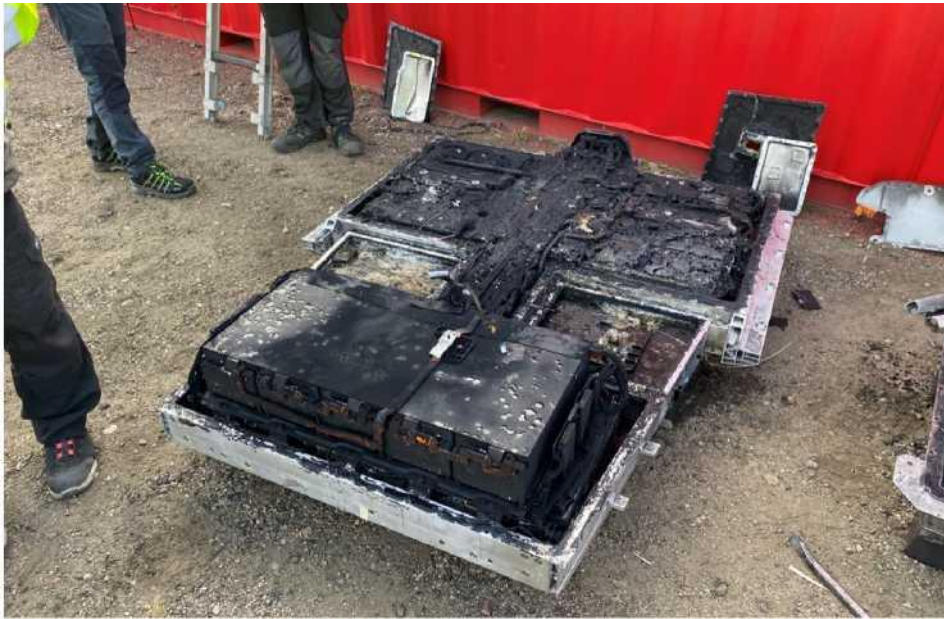
**Figure 17.** Detached electric car battery after extinguishing with lid removed - test 2.

The voltage measurements of the battery modules showed that the two modules where thermal runaway was initiated had 3 volts and 12 volts respectively. Of the battery modules, 17 out of 24 had stranded energy. Figure 16 shows the voltage distribution in all modules and Figure 17 shows the battery after extinguishing.

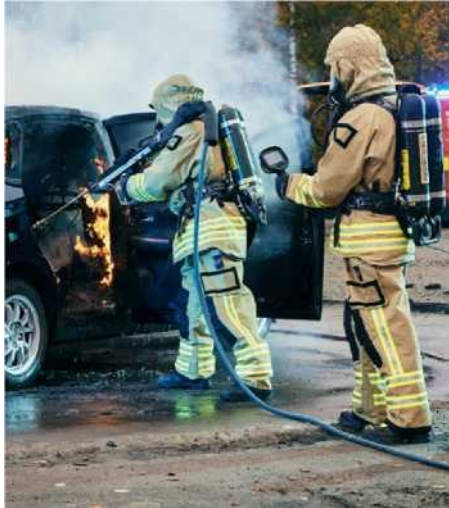
**Figure 18.** Firefighting with cutting extinguisher on electric vehicles (image from a separate project, but depicts the same type of operation).

Thermal runaway was initiated in ignition module number 7 (battery module A) and the first signs of thermal propagation came quickly in the form of visible smoke. Within 3 minutes of the first signs of thermal runaway, flames were observed. After fifteen minutes, a fully developed fire was observed in the vehicle and extinguishing was initiated (see Figure 18).

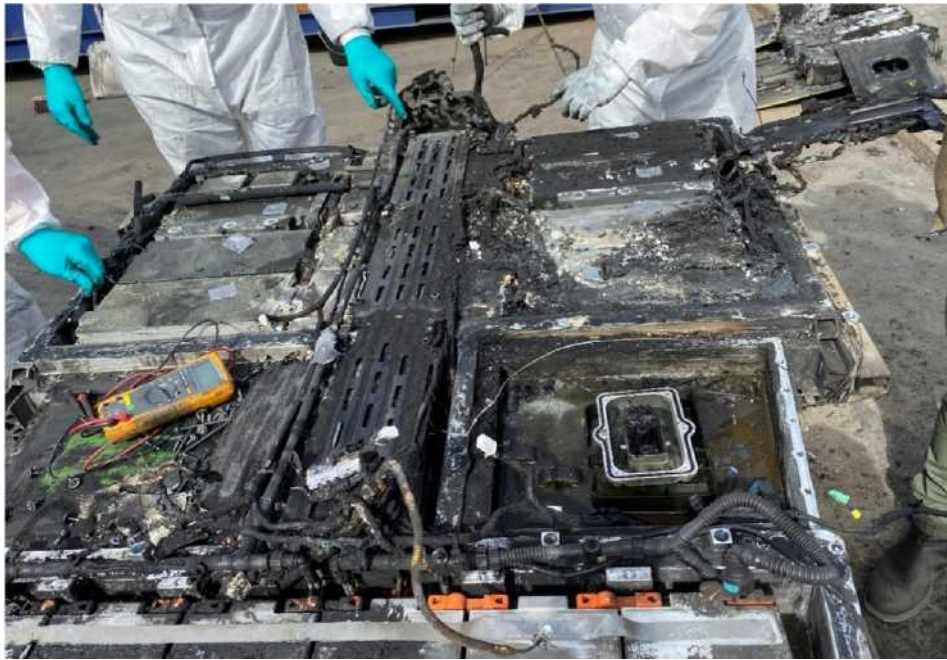
**Figure 20.** Battery pack removed from electric vehicle after extinguishing - test 3.

The voltage measurements of the battery modules showed that the module attacked by the cutting extinguisher (number 16) had no stranded energy. Of the battery modules, 22 of 27 had stranded energy. Figure 19 shows the voltage distribution in all modules and Figure 20 shows the battery pack after it has been removed from the vehicle two days after extinguishing.

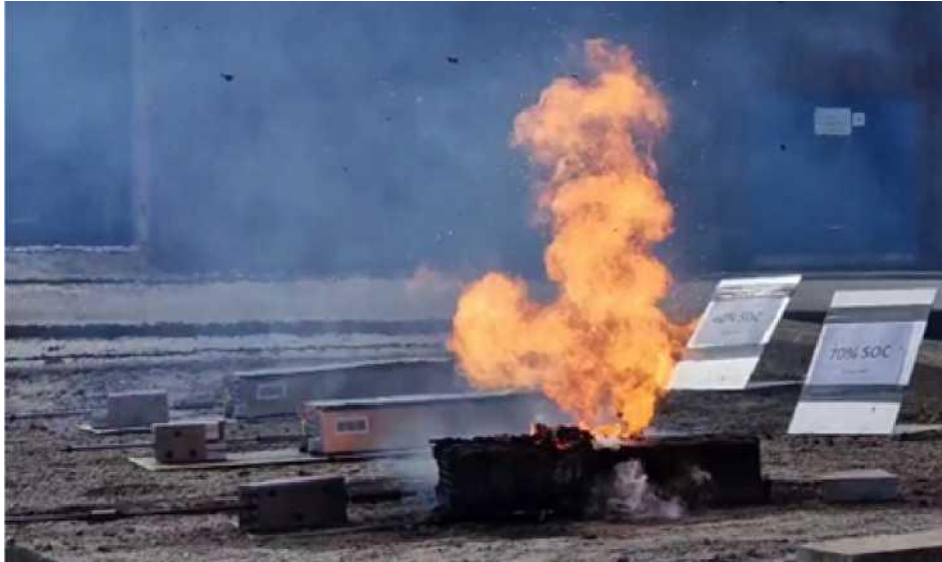
**Figure 21.** Course of fire in battery module (100 % SOC).

Test 4 examined the significance of SOC. The fire's course at 100 % SOC was experienced as very reactive, as well as at 70 % SOC. The third battery module, with 40 % SOC, had a somewhat calmer course. Course of fire at 100 % SOC is shown in Figure 21.

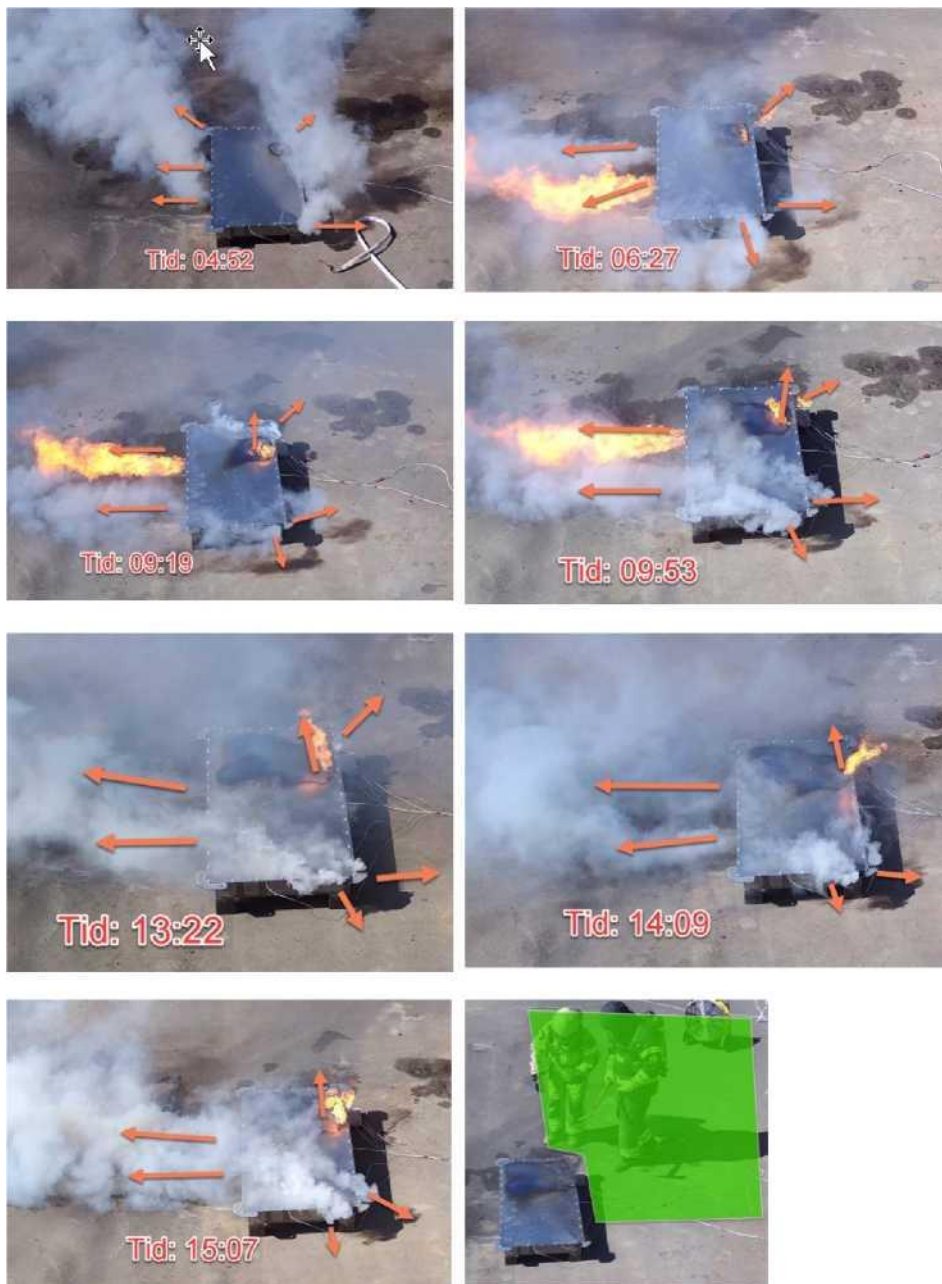
**Figure 22.** Example of smoke and flame propagation from the sub-pack in test 1C. The thermal propagation pattern varies between different vehicles and battery architectures and must be studied on a case-by-case basis before first responders approach the fire scene. The green shape shows the area deemed safe in this case.

Figure 22 shows an example of smoke and flames propagating from a battery in the current demonstration. The green shape shows the area deemed safe in this case. Since the spread depends on several factors, no general conclusions can be drawn about safe zones, but it is necessary to observe the behaviour of the fire in each individual case. Factors involved in the spread of fire include the following:
